*Journal of Advanced Research in Applied Mechanics* 1(1), Issue 1 (2023) 62-73

**Crack Propagation Analysis of Fatigue Due to External Corrosion on the Construction of the Ferris Wheel in Alun-Alun Kota Batu**

## Crack Propagation Analysis of Fatigue Due to External Corrosion on the Construction of the Ferris Wheel in Alun-Alun Kota Batu

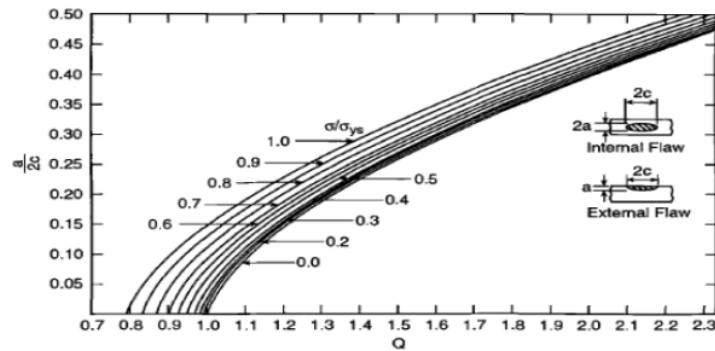
Fig. 2. Crack defect parameters in surface crack conditions

The Q value is obtained from the flaw shape parameter Q graph, as shown in Figure 2, by connecting the values  $\frac{a}{2c}$  and  $\frac{\sigma}{\sigma_{ys}}$  [5].

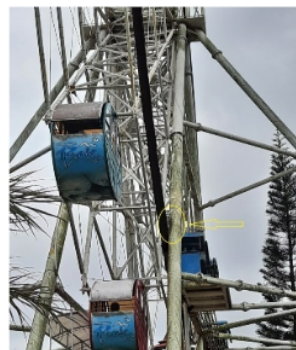
Fig. 3. Location pipelines

Propagation rate of fatigue crack ( $da/dN$ ) versus intensity of strength ( $K$ ) and their trend line that As welded A 36 have  $C$  is  $2.161 E^{-11} - 6.171 E^{-11}$  and  $n$  is  $4.112 - 4.127$ . Failure occurs when  $K_I = K_{Ic}$ . In this case,  $K_I$  is the driving force for fracture, and  $K_{Ic}$  is a measure of material resistance. As with  $G_c$ , the property of similitude should apply to  $K_{Ic}$ . That is,  $K_{Ic}$  is assumed to be a size-independent material property. (Subeki 2017, subki 2017). Figure 3 shows the location pipelines.

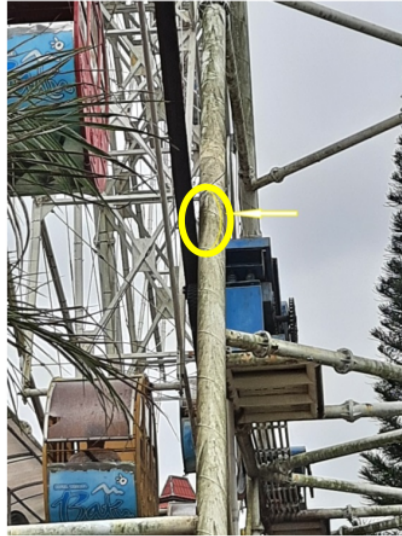
**Fig. 4.** Friction between the rim and the support pipe that causes happening scratches/flaws

Form construction Ferris the high, rotating wheel, is also very prone to burden dynamic. It can trigger happening propagation cracked fatigue due to external corrosion cracks, as in Figure 4.

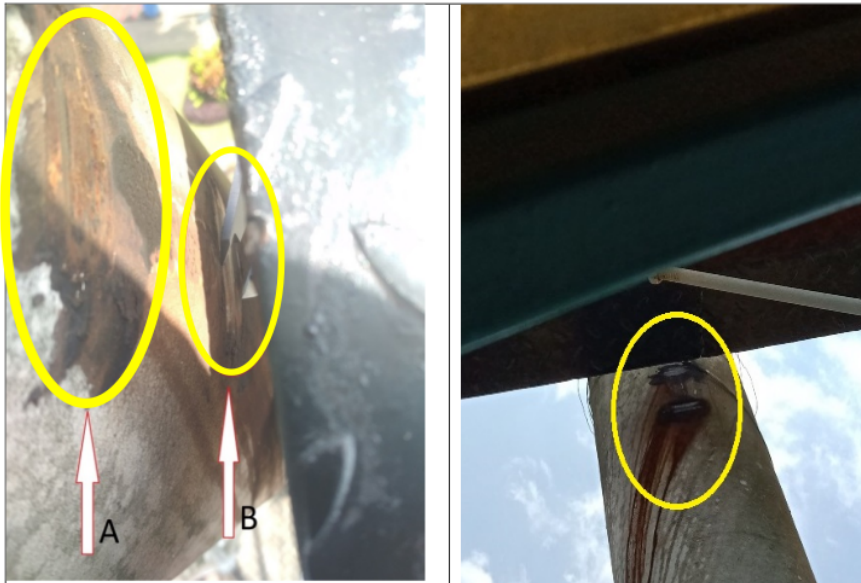
**Fig. 5.** Locations A and B of scratches/defects and corrosion on steel pipes buffer Ferris wheel consequence friction with rims

Figure 5 forms from defects that occur consequence tilt of the Ferris wheel so that the rim and rod pipe support experience friction. It resulted from the formation of a disabled semi-elliptical. Especially aggravated with exists suitable corrosion with indication exists propagation cracks that occur.

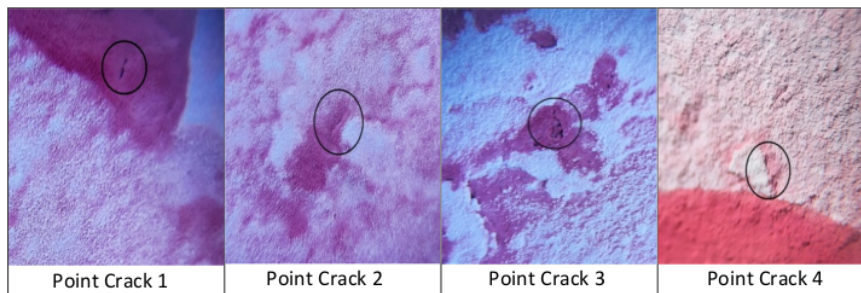
Fig. 6. Macrographic results from penetrant testing at the defect inspection point

They did Liquid Penetrant Test because it can detect open macro cracks from the material's surface. This test aims to detect the presence of cracks at the point of defect. The following is a macrographic image and table of Liquid Penetrant Test results on defects A and B at the inspection point.

From inspection, The Liquid Penetrant Test and macrographic results above obtained data from the inspection point, as shown in Figure 6 and Table 1. From the inspection results Non the Destructive Test with the Liquid Penetrant Test method at location points, the defect is visible with indications of cracks at 4 points at defect locations A and B. The most extended crack indication occurs at point 3 along 8.3 mm. Meanwhile, the shortest crack happens at point 4 along 5.5 mm. With the above test, it was obtained that the initial crack sides were visible, then the crack propagation was indicated by the beach mark. An indication of crack propagation occurs, namely the presence of beach marks around the location of the crack indication [9, 20].

or up to 70% pipe thickness. When *the crack* has passed the permissible tolerance, the material must be replaced immediately to anticipate failure that will occur. Cracks that start at critical locations can cause the failure of the structure if its presence is not known. Moreover, it is exacerbated by the fact of corrosion [23].
